The PEPCON Disaster – Causative Factors and Potential Preventive and Mitigative Measures

H. E. Lambert, N. J. Alvares

Fourth International Seminar "Fire and Explosion Hazards",
Londonderry, Northern Ireland, UK, September 8-12, 2003

THE PEPCON DISASTER – CAUSATIVE FACTORS AND POTENTIAL PREVENTIVE AND MITIGATIVE MEASURES

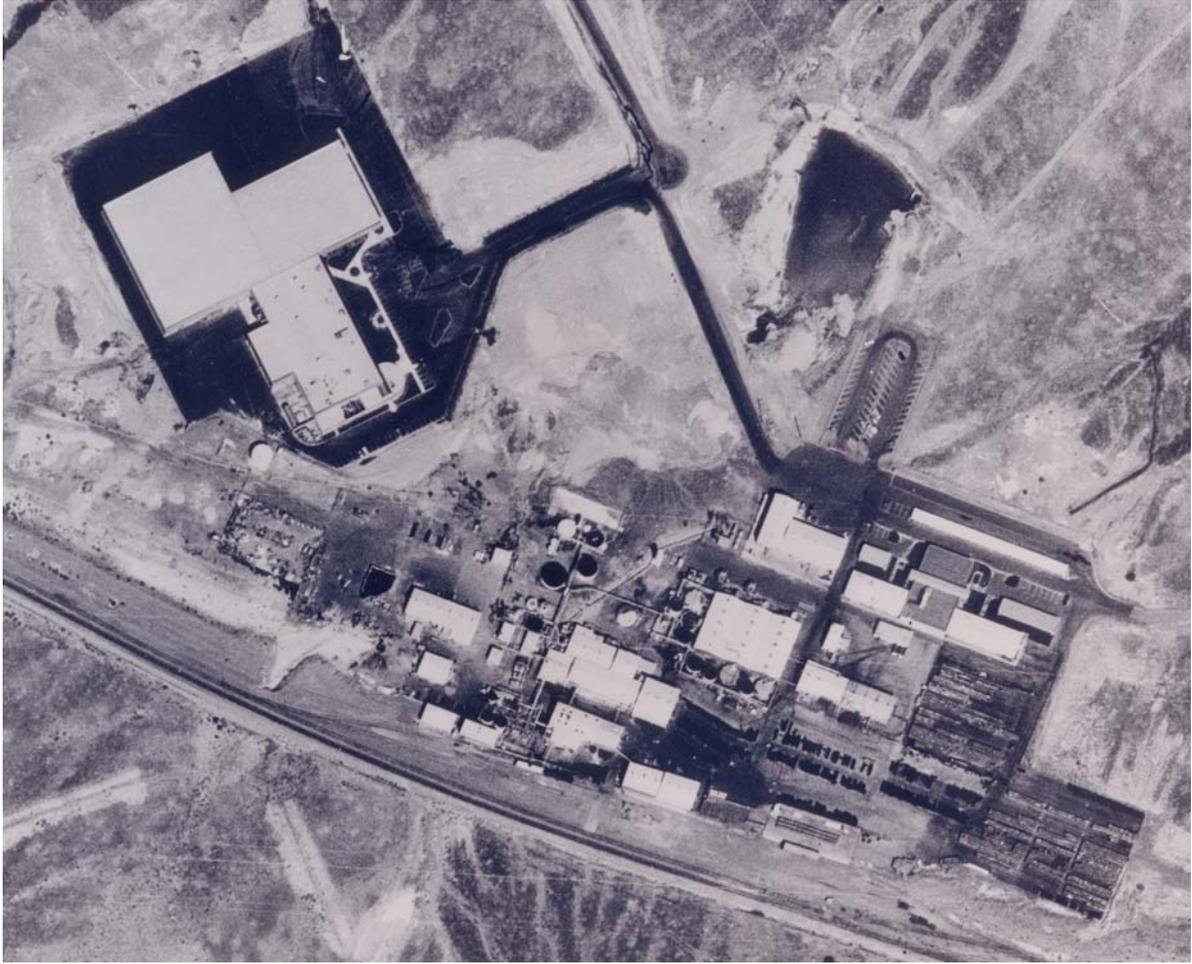
A variety of AP inventory containment options were used at Pepcon for bulk storage of product in line for final blending and for final shipment. These included; Aluminum bins of capacity of 5000 lbs (2268 kg), polyethylene lined steel drums of capacity of 250 lbs (113 kg) and bulk storage bags made of fiber reinforced polypropylene of capacity of 2400 lbs (1134 kg). The bins and bulk storage bags were also equipped with plastic containers for desiccants. In addition, over 10,000 drums made of high- density polyethylene with a capacity of 550 lbs (250 kg) were stored at various locations around the site. Generally, these drums contained product slated for intermediate procedures and blending. All the containers were composed of, or contain oxidizable materials. In addition, the majority of pavement for roadways and bulk storage fields was asphalt of which 25% is petroleum base material. The total inventory of AP at Pepcon at the time of the explosion was over 8,500,000 lbs (3,860,000 kg) distributed as shown in Fig. 1.

Figure 1. Aerial photograph of plant prior to explosions and fire.

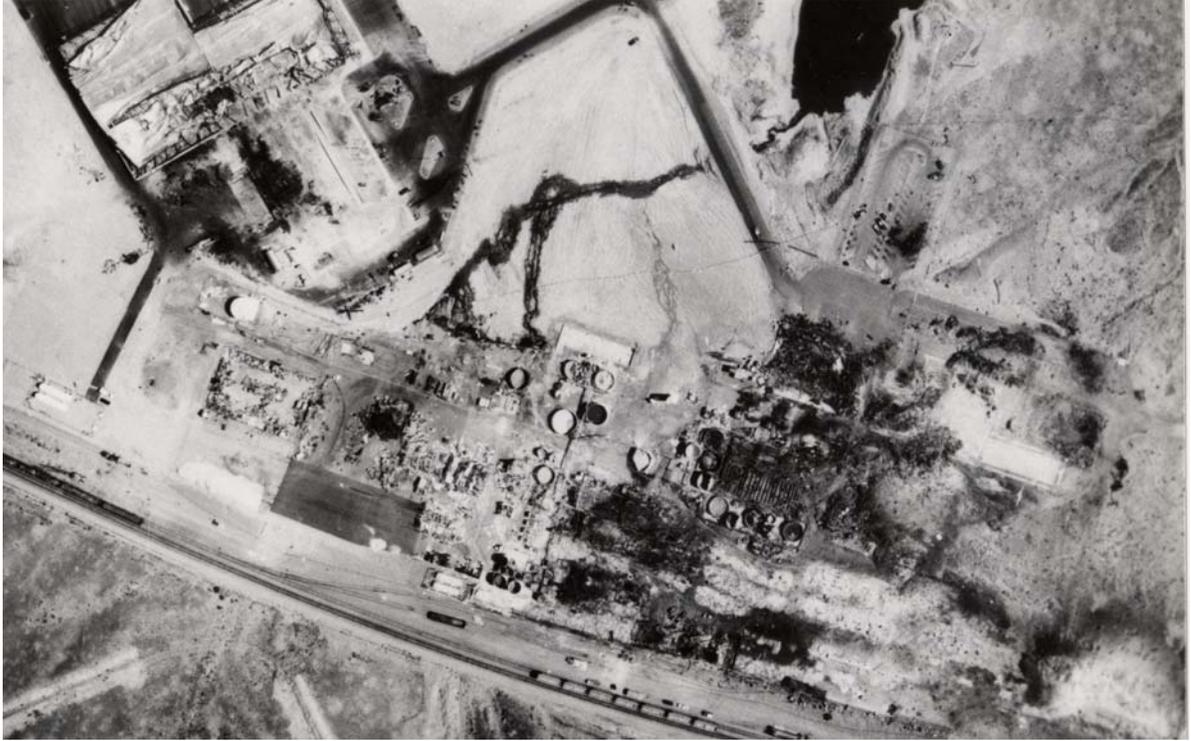
Pepcon was obviously aware of the fire risk of AP and production engineers were probably cognizant of the potential for explosion of bulk quantities of AP from past experience and transportation regulations. [5]. Moreover, experience of ignitions of AP sensitized organics at the Pepcon plant gave fair warning that they were working dangerously close to the safety limits of some process procedures. Nevertheless they pioneered the use of Poly drums for convenience and for corrosion control knowing that the combination of organic materials with oxidizers was unwise. Indeed, simple comparison of the explosion energy of AP alone and AP in combination with the mass of polyethylene of a poly drum is astounding especially considering the ignition sensitivity enhancement provided by the combination. Thermodynamic evaluation of the internal energy and entropy of explosion for pure AP and AP in stoichiometric combination with polyethylene or asphalt show that the explosive strength, referenced to TNT is 0.5 and 1.5 times TNT respectively [6]. Clearly, the mass ratio for polyethylene drums and the AP content was oxidizer rich and the consequent energy release less than the stoichiometric ratio. This is consistent with independent analysis based on close-in structural deformation, which suggested a TNT air blast equivalence factor of 0.333, relative to the total inventory of AP on site [7]. The results of these explosions are shown in Fig. 2 and 3.

Figure 2. Aerial photograph of plant post the explosions and fire.

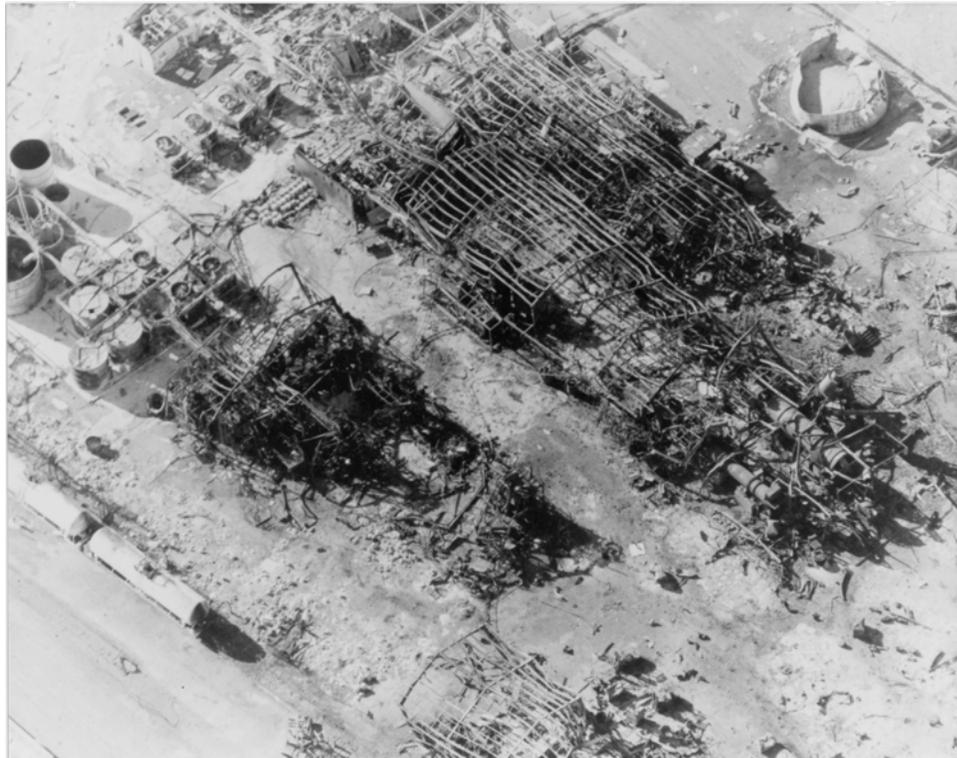
Figure 3. Aerial photograph of fire and explosion damage to process buildings around the batch dryer building.

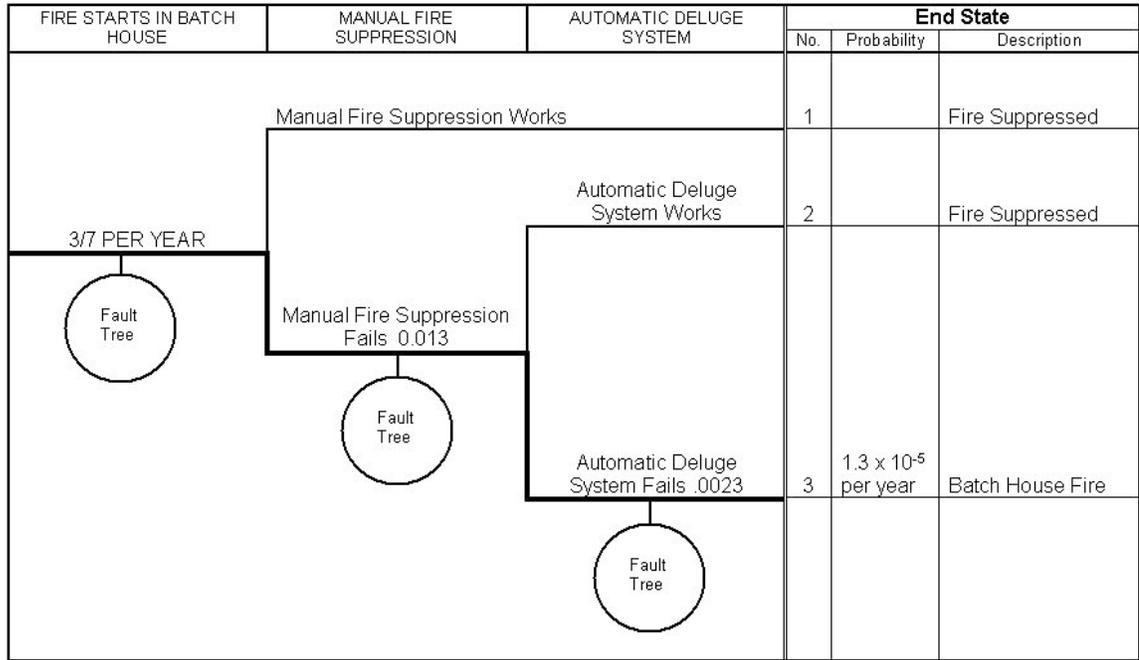
Figure 5. Event Tree Fire in Batch House Recommended System

suppression system was recommended. (The details of this system are described later.) The event tree with all the proposed preventive and mitigative features are shown in Fig. 5. Fault trees were constructed and probabilistically evaluated to estimate failure probabilities for the manual fire suppression system and automatic deluge system.

The top event probability (probability of failure for manual extinguishment) is calculated to be 0.013. The fault tree for the automatic deluge system is shown in Fig. 9. This fault tree shows the dominant causes of failure that include failure of the manual locked open manual valves, check valve failure and inadequate water supply in the fire tank. Failure of the pumps and signal actuation system did not dominate probabilistically due to redundancy. The top event probability for failure of automatic deluge system given a fire is calculated to be 0.0023. From Fig. 5, the total frequency of a batch house fire with recommended measures employed is:

The study recommended the inclusion of trained personnel that know how to manually extinguish a fire and conduct a fire watch in the event welding or hot work is occurring. The study recommended the use of hose system as the first line of defense in extinguishing a fire. In addition, the inclusion of an automatic fire

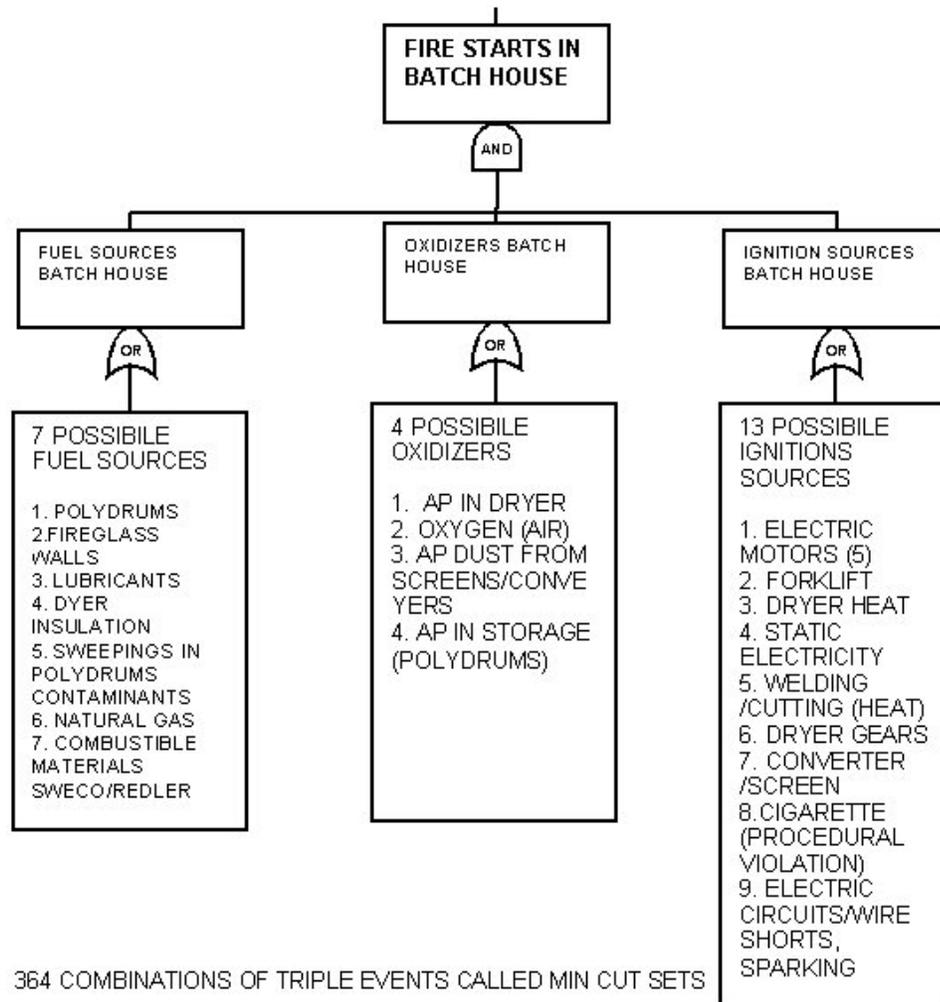
Figure 6. Fault Tree for Fuel/Oxidizer/Ignition Source

A fault tree is a deductive logic model. The fault tree starts with a defined top event, uses standard and or gates, is developed to the limit of resolution, called basic events. Basic Events include (1) equipment failure, (2) human error and (3) environmental conditions. A fault tree in Fig. 6 was used to generate the combinations of fuel sources, oxidizers and ignition sources. This fault tree is similar in scope to an interaction matrix. The study identified 7 possible fuel sources, 4 possible oxidizers and 13 possible ignition sources. There are a total of 364 combinations of triple events called min cut sets. The authors judge that the most likely ignition source for the batch house fire is incandescent particles from welding and/or flame cutting. An alternate ignition candidate is judged to be heat from the dryer that on previous occasions has ignited the dryer insulation made from cheesecloth.

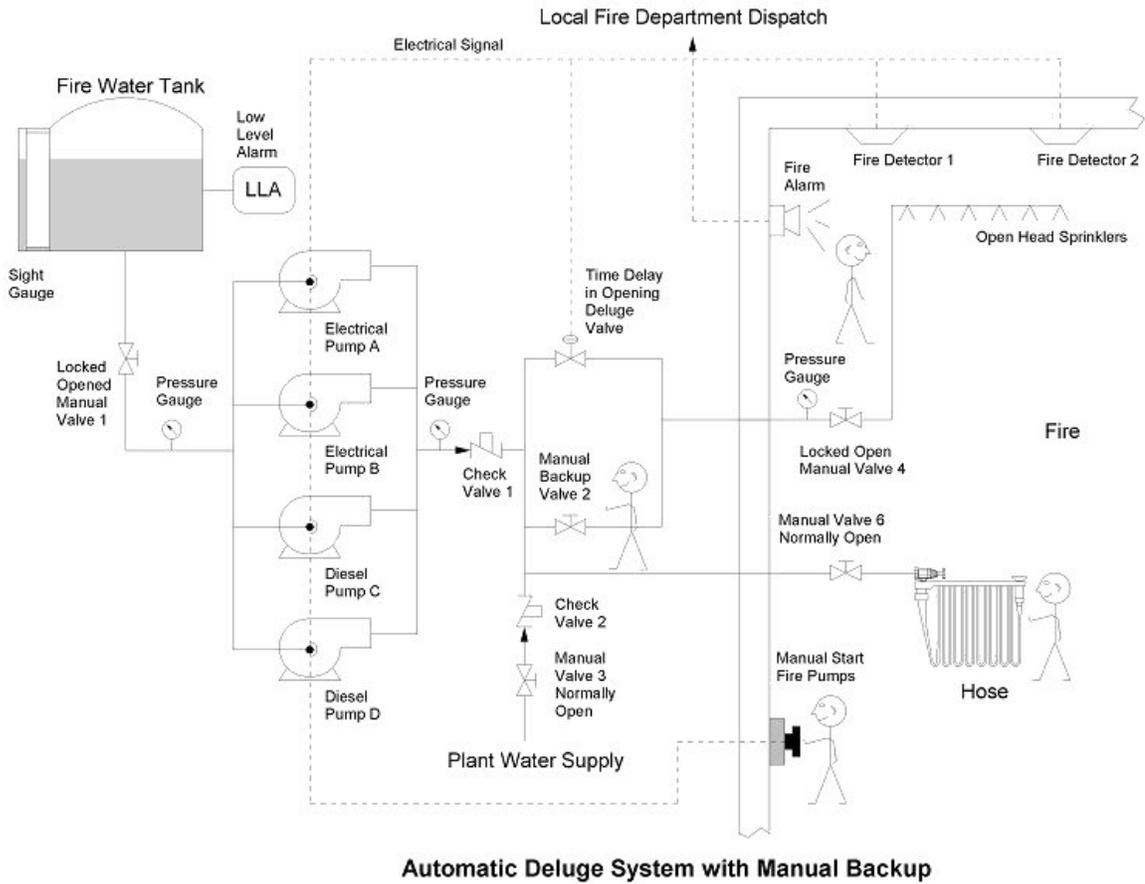
Figure 7. Automatic Deluge System with Manual Backup

The study recommended the inclusion of water deluge system shown in Fig.7.

1. A dedicated fire water supply system with a fire water tank and four pumps, two electric and two diesel driven
2. Automatic activation with at least two fire detectors and an automatic deluge valve
3. Manual Activation with a manual backup valve, a fire alarm to alert the operators and manual start of the pumps
4. A hose system that is used for manual fire suppression – the first line of defense for fire extinguishment

1. Check fire water level once a month
2. Every six months test fire water pumps, fire alarm, fire detector and deluge valve

3. Once every year, full test of deluge system

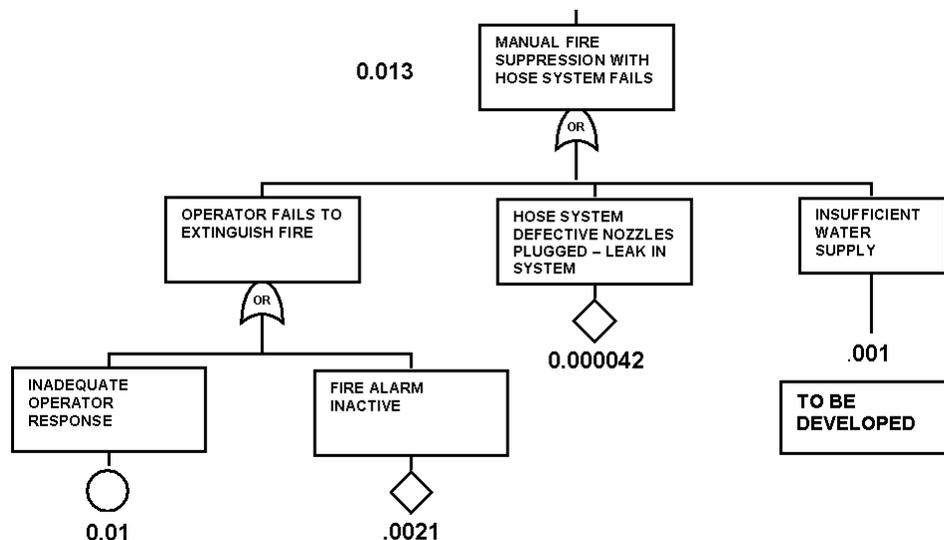
Figure 8 - Top Level Fault Tree For Manual Fire Suppression

The top level fault tree for manual extinguishment is shown in Fig. 8. The fifth step of the process was to quantify the fault trees and apply applicable probability data. The probability data that was used include Swain and Guttman, NUREG 1278 [14], Interim Reliability Evaluation Program, NUREG 2728 [15] and RADC, Non-electronic Reliability Notebook [16].
